Aftermarket Hazard Detection for Cyclists

Team 19

December 5th, 2023

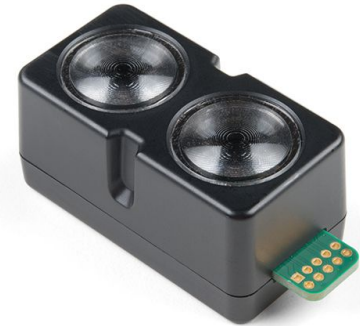
LiDAR

Pros

- High accuracy
- Medium range

Cons

- High cost

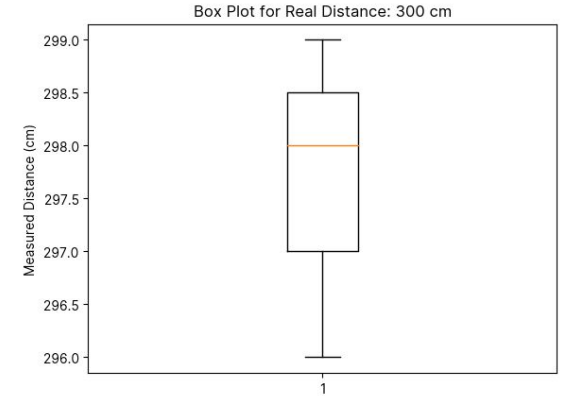
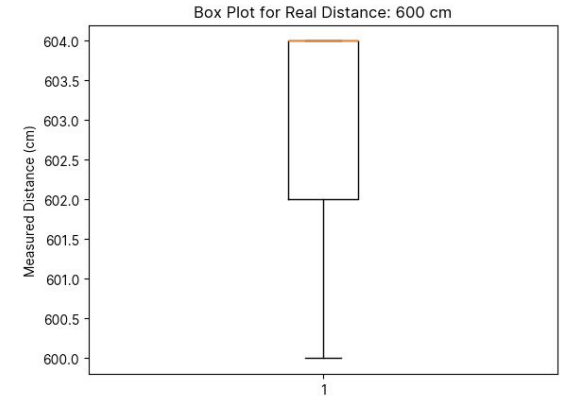
HLR: Sensing/Ranging (cont.)

- **Fixed LIDAR ranging against static medium/high reflectivity targets**
 - ~ 80-90% reflectance
- Moved target to specified stop
- Read out measurements from LIDAR sensor via I2C
- Preliminary trials data
 - 3 trials at 7 distances
 - 0-600 cm
- Average Error: 1.66 cm

- **LIDAR unit is extremely accurate from 0-7 meters**
 - ± 1 cm at all sub-seven meter ranges
- **LIDAR has problems at further distances**
 - Large variation and false positives
 - Up to ± 20 cm variation at 7-10 meter ranges
 - Periodic drops and spikes to high or low
