# Heat Leakage Measurements Utilizing An Airborne Sensor Package

12/6/2019

University Of Illinois

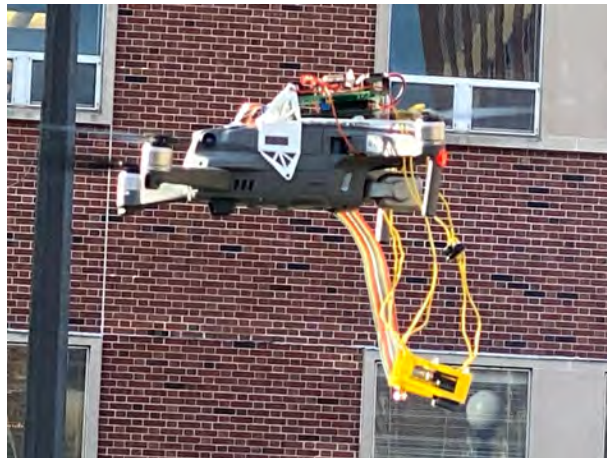
Image 2: Sensors and processor 3-D Printed Apparatus on Drone

In designing a system capable of being attached to the drone, certain guidelines had to be followed. We would have liked to mount a processor to the bottom of the drone. However, this approach would have blocked the drone's sensors on its underside, which prevents the drone from flying and landing properly. To address this issue, we designed an apparatus that places devices on both the top and beneath the drone. This approach overall involves three components: a main package attached to the top of the drone which consists of the central processor and the other devices too large to place below the drone, a package containing our sensors designed to be held a distance away from and under the drone's own sensors, and a mount capable of supporting such a processor and a hanging set of sensors (Image 2).

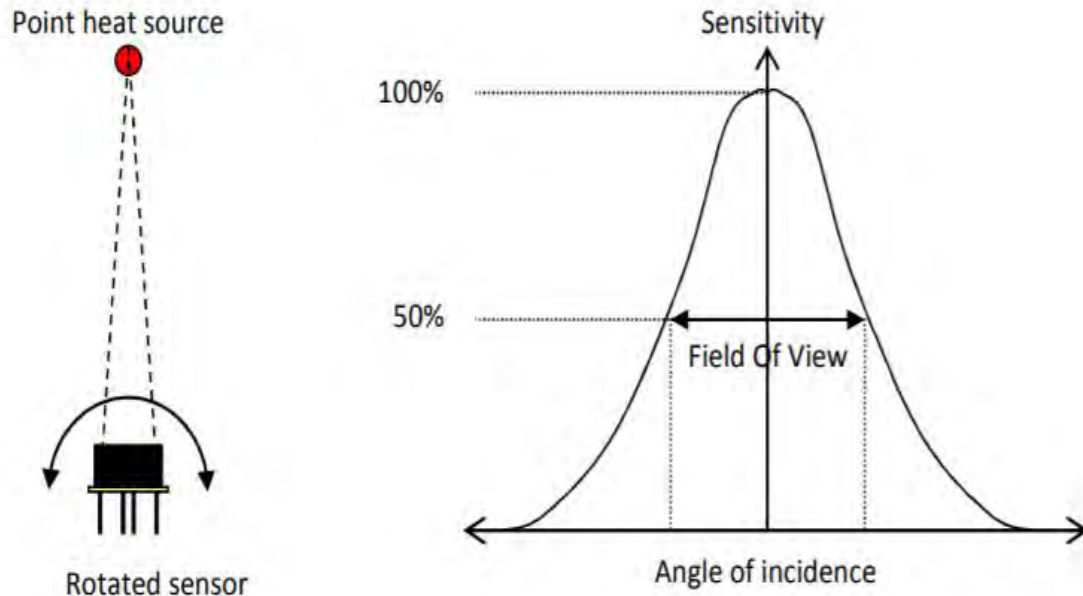
Image 3: Diagram of MLX angle of incidence from datasheet<sup>2</sup>

The array of sensors we used includes a three volt MLX90614 IR sensor for the temperature and an Ultimate GPS breakout board to track the position. The MLX utilizes a 90 degree field of vision to measure IR radiation emitted from the roof's surface and averages the values absorbed. Image 3 shows that the sensitivity of the sensor is at 50% at an angle of incident of  $45^\circ$ . By assuming a perfect blackbody surface, the MLX processes the incoming IR radiation as

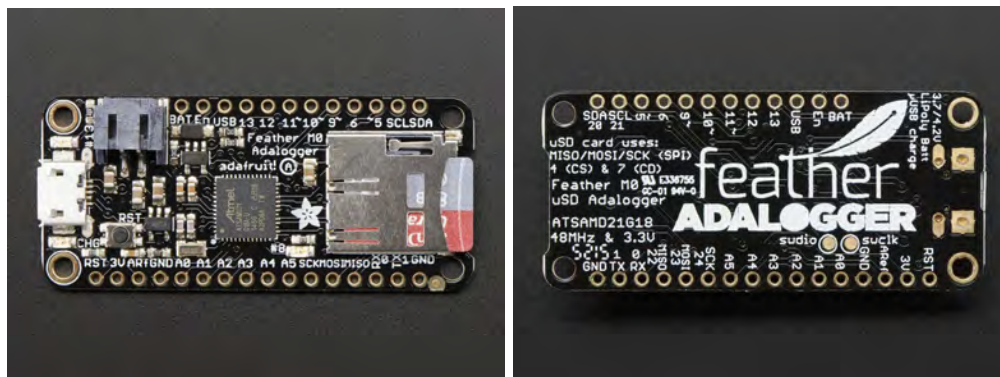
Image 4. Adafruit Feather M0 Adalogger

The central processor for the sensor package is a Feather M0 Adalogger (Image 4). The Adalogger allows for a compact and lightweight processing unit, weighing 5.3 grams. The processor serves as the source for I2C communication, a form of serial communication, used by all of our included sensors except for the Ultimate GPS, which uses a different form of serial communications. I2C serves as the protocol for our devices to communicate data with our Adalogger, and works by transferring data bit by bit from the sensor to the processors. The bits are synchronised between processor and sensor via a shared clock signal. The GPS uses a TX data line to transmit data to the Adalogger and a RX data line to receive data/instructions from the processor. Onboard the Adalogger is a microSD card reader/writer which saves space on the main board as well as giving us the means necessary to write the data gathered from our data collections. The complete package of processors plus sensors is shown in Image 5.

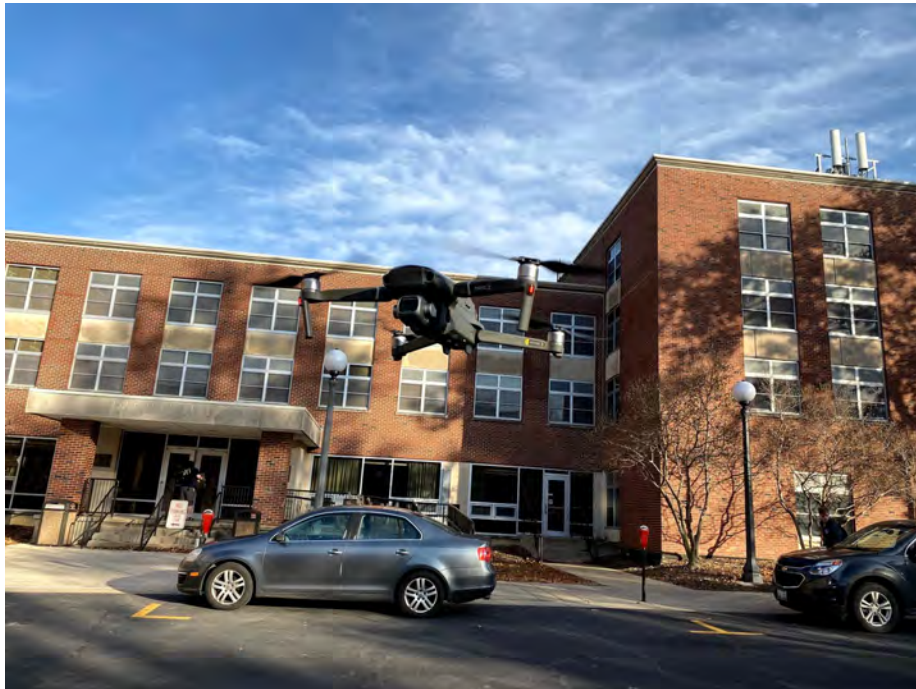
Image 6. Drone without Sensor Package

The DJI Mavic 2 Pro (Image 6) is a maneuverable drone that weighs two pounds.<sup>4</sup> It offers a superlative 4k supported video feed with useful GPS and barometric/IR altimeter readings. These devices help provide comparative real time data for the sensor package measurements. Our package is mounted via a 3D-printed basket and cage system. The processing board is mounted atop the drone while the sensor package is suspended approximately 20cm from the underside of the aircraft. The sensor package is placed in a similar printed basket that is secured by wire to each arm of the drone. The sensor package hangs below the DJI MAVIC 2 Pro. The processing board sits above on the mount.

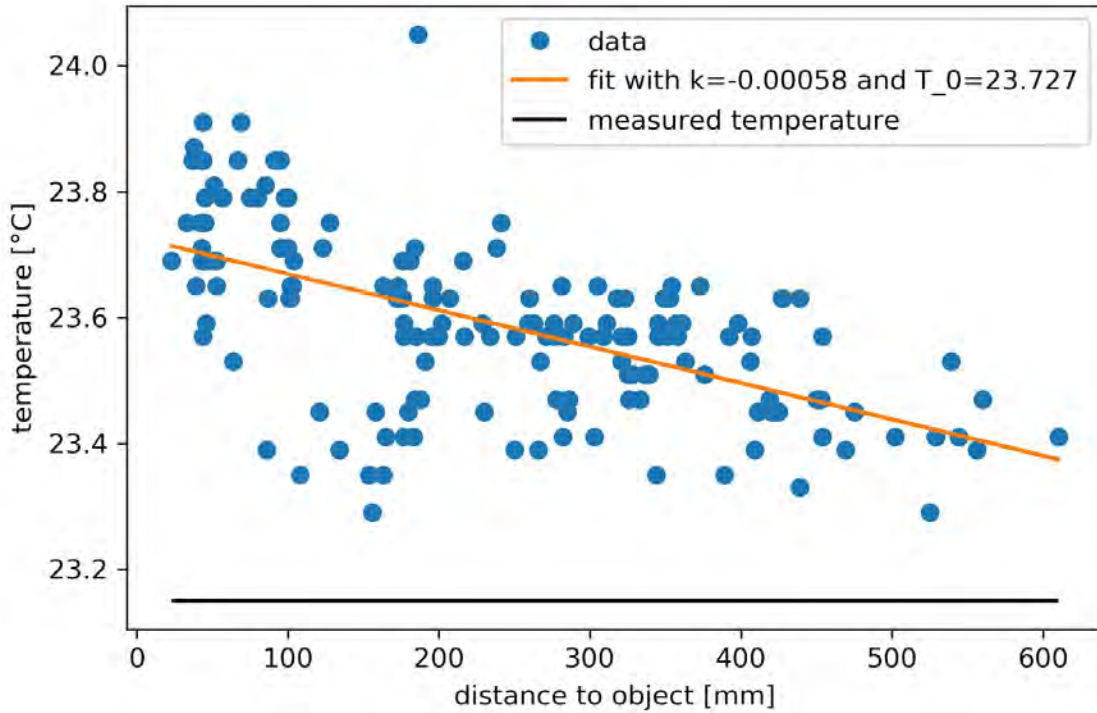
Figure 1 calibration measurement between measured temperature of a blackboard versus the measured distance to the blackboard. The orange line shows a linear fit that was fitted to the data. The black line shows the actual temperature of the blackboard measured via a thermocouple.

Figure 1. Blackboard Temperature Calibration

The next step was to calibrate the measured temperature. Therefore, a calibration measurement was conducted by using the device to measure the temperature of a blackboard with the distance to the object. Figure 1 shows the result of this calibration measurement. The data points are plotted in blue on a temperature versus distance graph. One can see that the measured temperature decreases with increasing distance. This data was fitted by a straight line:

where  $T$  is the measured temperature of the blackboard,  $d$  representing the distance of the sensor to the object, and  $k$  and  $T_0$  are the fitting parameters. The black line in the figure shows the measured temperature of the blackboard according to a thermocouple which is known to be accurate. Using the determined parameters for  $k$  and  $T_0$ , it was possible to calibrate the measured temperatures of the following measurements by using:

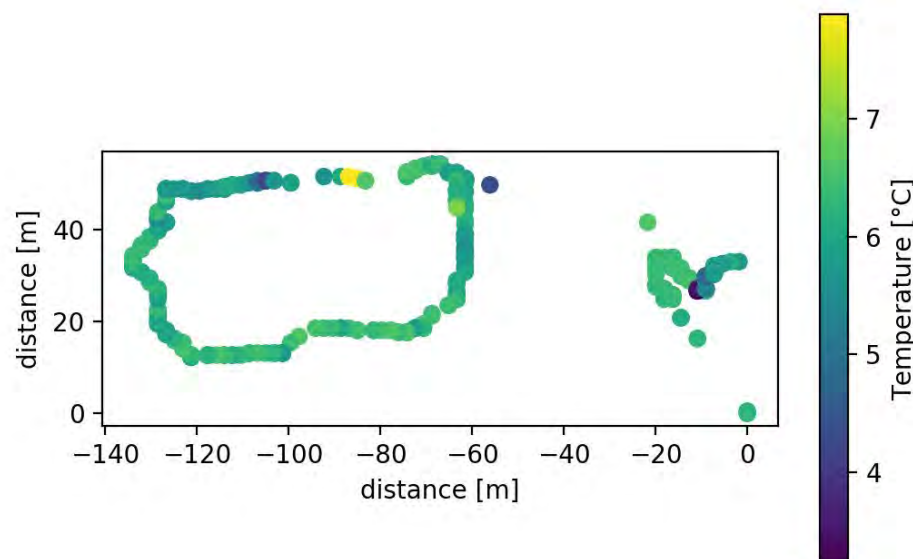
Figure 3. Loomis Roof Temperature 18th Nov (No Satellite Underlay)

Figure 3 displays the same flight from Figure 2 but without the satellite image background. We notice the building is particularly warmer on the south segment of flight. The eastern and northwestern corners have an average of 5.5 °C while the south side is approximately a half degree warmer. The strangely out of place hot point on the north side of the building is not to be taken with much interest. The north side has many gas tanks and antenna scattered about. The flight segment was approximately flown straight but altitude was increased to avoid the obstructions. This sensor height increase is evident in Figure 5 where the distance is mapped to the temperature around the roof. The ambient temperature outside was approximately 4 °C at 10 am on 19 Nov 19<sup>7</sup>. The weather was completely cloudy so there were no shadows, thus the roof is assumed to be approximately at equilibrium.

We can see from Figure 3 that the northern and eastern sides of the roof are cooler and the southern region in particular is above average which may further support possible heat leakage in this region. Figure 4 restricts the temperature range for better observation of the temperature discrepancies previously described. We were able to reproduce these results similarly on November 20th as seen in figure 6 with an ambient temperature of 5 °C and sunny weather. In this 2nd run the north side is much cooler due to the central roof's shadow being cast over the north segment of the flight. Figure 4b displays the temperature as a function of time during the course of the November 18th flight. The sharply sloped line indicates the rapid air temperature drop as the drone flies from its launch pad up to the rooftop. Table 3 shows important statistical properties of Figure 3.

Our most recent and most successful scans of the rooftop of Loomis Lab has presented us with a very useful set of data to analyze. For the majority of the run, the data points show a consistent temperature around the perimeter of the rooftop ( see Figure 3). However, there are a few points that show an increase in temperature. We cannot say conclusively that these spots represent notable heat leakage from the roof, as this may just be a source of increased temperature on the inside of the building. What we can conclude from this is what was previously stated, in that we have devised a valid method for analyzing rooftops and potentially other surfaces for notable temperature changes.

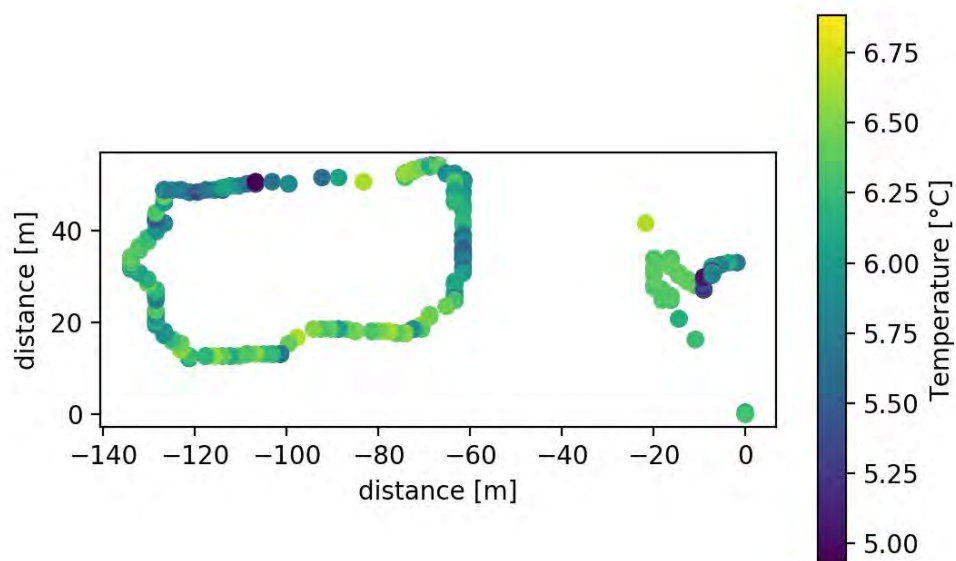
Figure 4. Loomis Roof Temperature restricted to 5°C to 7°C 18th Nov

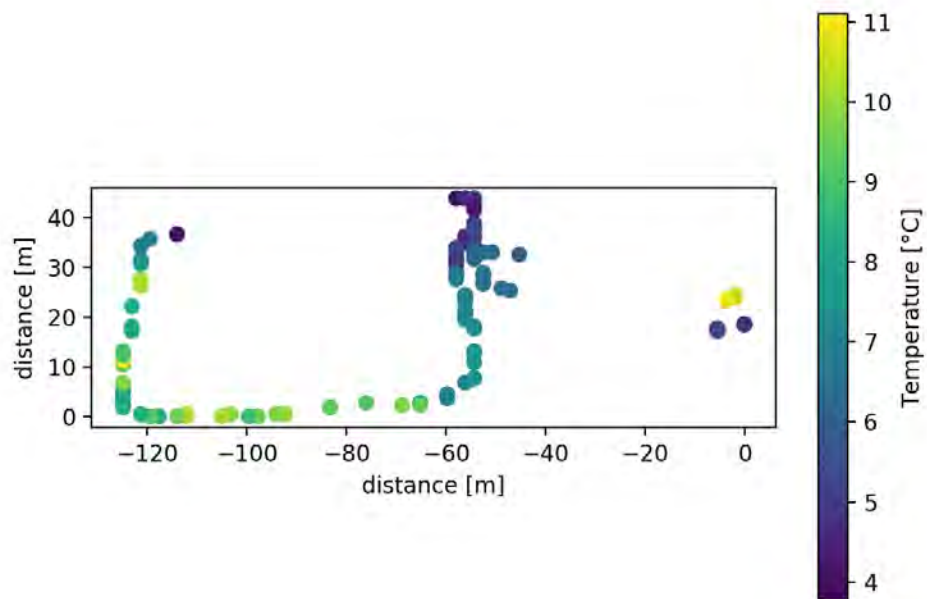
Figure 7. Loomis Roof Temperature (4-11°C) 22nd Nov at 2 pm

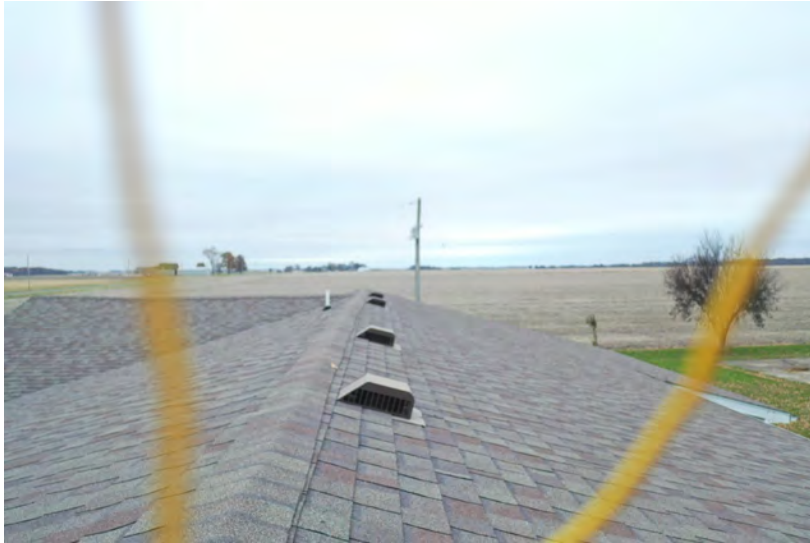
(c) Farmhouse Rooftop With Heat Vents (431 County Rd 700 N Sadorus, IL)

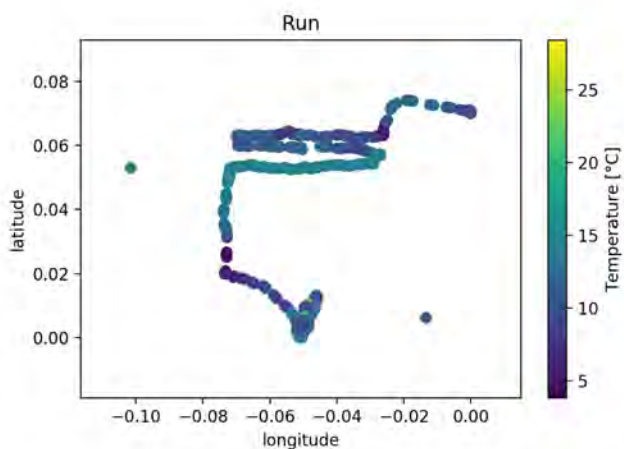
(a) Aerodynamics Research Building Multiple Pass Flight

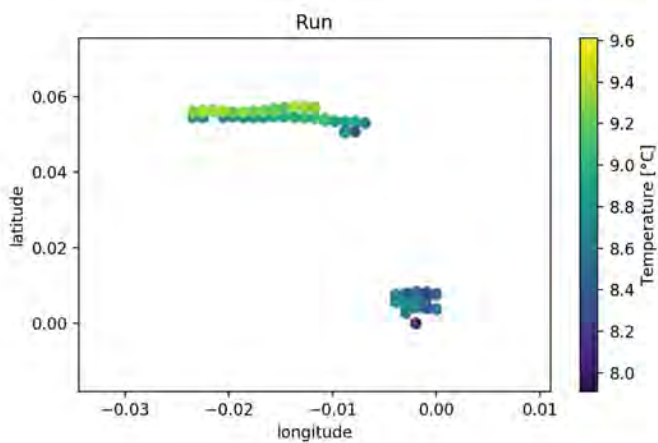
(b) Farmhouse Multiple Pass Flight

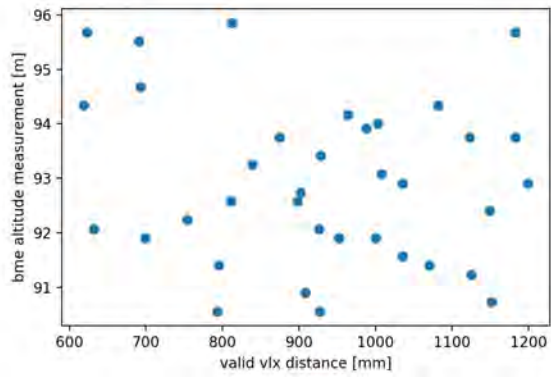
(d) Measured BME680 altitude vs measured VL53L0X distance to the object. Measurement taken on the rooftop of Loomis.

In addition, we tried to incorporate the BME 680 altitude measurements to the data to make up for the missing distance data. Therefore, we had to correlate the distance measurements of the VL53L0X and the altitude measurements from the BME680, but we found that there is no correlation between those two measurements (see Appendix B: Plot d.). This leads us to believe that the BME680 is not accurate enough to be a useful tool for our experiment.
